**Joint Investigation Report**

**On the Attack  
Against ROK Ship  
Cheonan**

Ministry of National Defense  
Republic of Korea

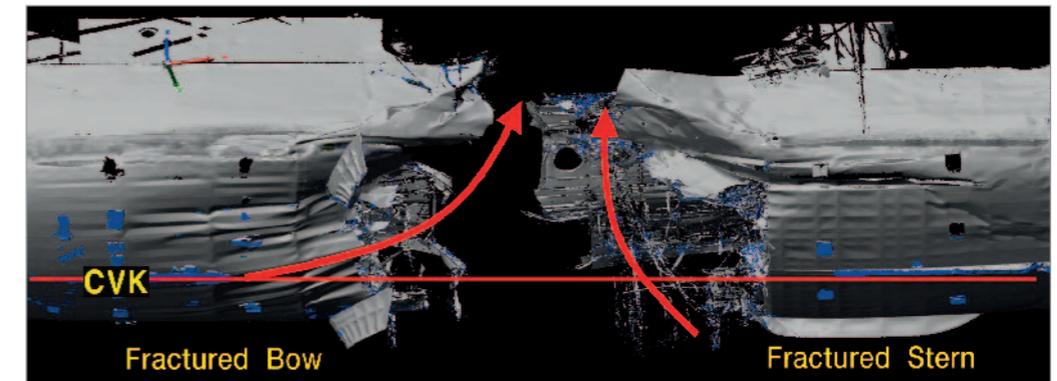
<Figure Summary-1> 3D laser scan image of the fractured bow and stern

First, a precise measurement and analysis of the damaged hull showed that a shockwave and bubble effects caused significant upward bending of the CVK(Center Vertical Keel) compared to its original state. The shell plating was steeply bent, with parts of the ship fragmented. On the main deck, fracture occurred along the large openings used for the maintenance of equipment in the gas turbine room, and the portside was deformed significantly in an upward direction. The bulkhead of the gas turbine room was significantly

As seen in <Figure Summary-1>, the upward bending of the bottom of the stern and bow indicates that an underwater explosion took place.

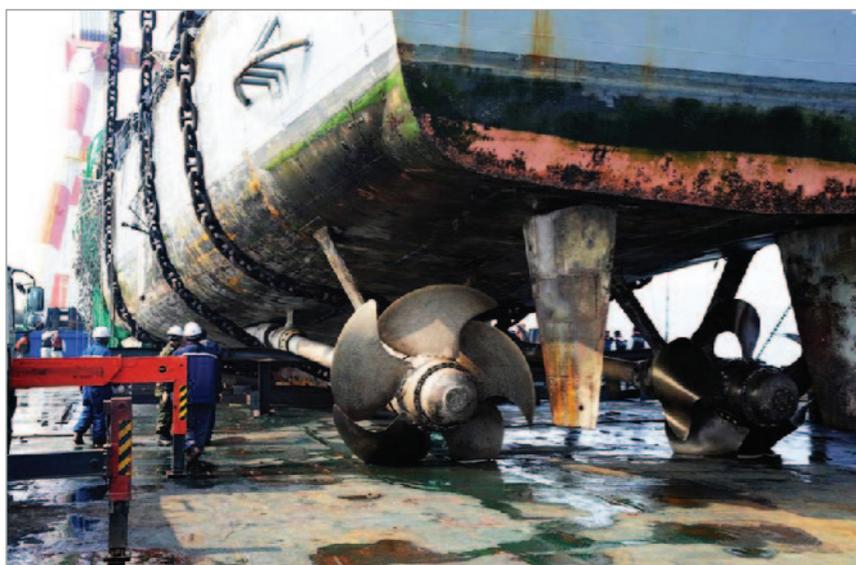
〈Figure II-1-2〉 ROKS Cheonan propellers upon the recovery of the stern

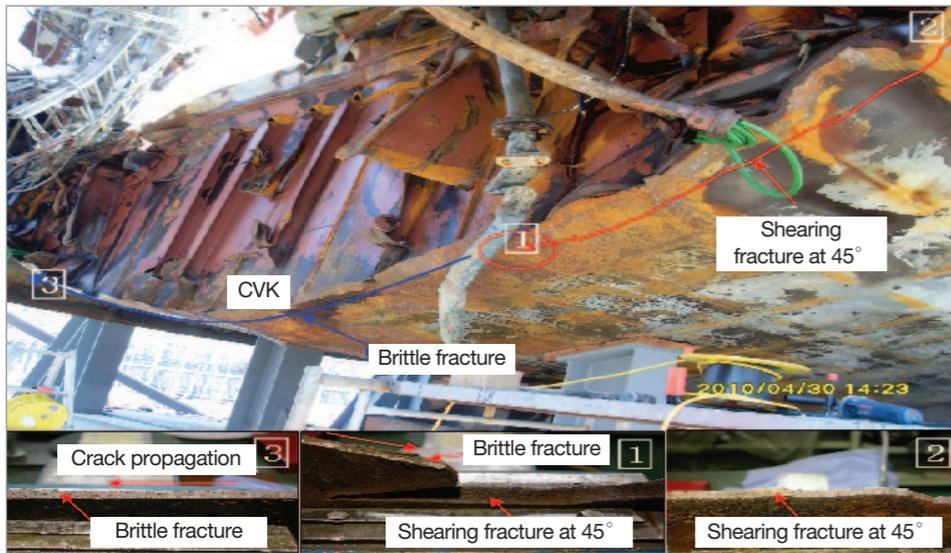
〈Figure II-1-6〉 Analysis result on the damage characteristics of the fractured surface seen on ROKS Cheonan

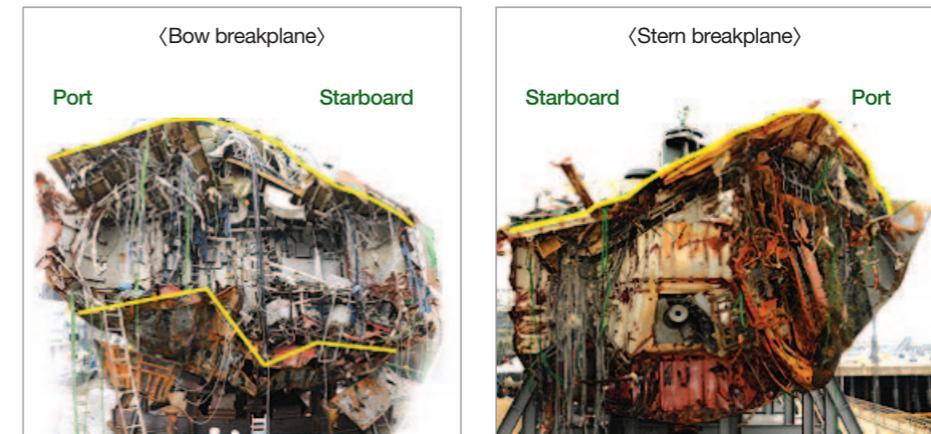
<Figure II-1-10> Breakplane of the bow and stern

A close inspection on the breakplane of ROKS Cheonan reveals that the bottom of the bow was bent upward, while the stern portside bottom was deformed extremely upward to the main deck level, to the point that it is almost not recognizable(See <Figure II-1-10>). The fractured surface on the bottom of the stern is cut clean at in front of the transverse bulkhead.

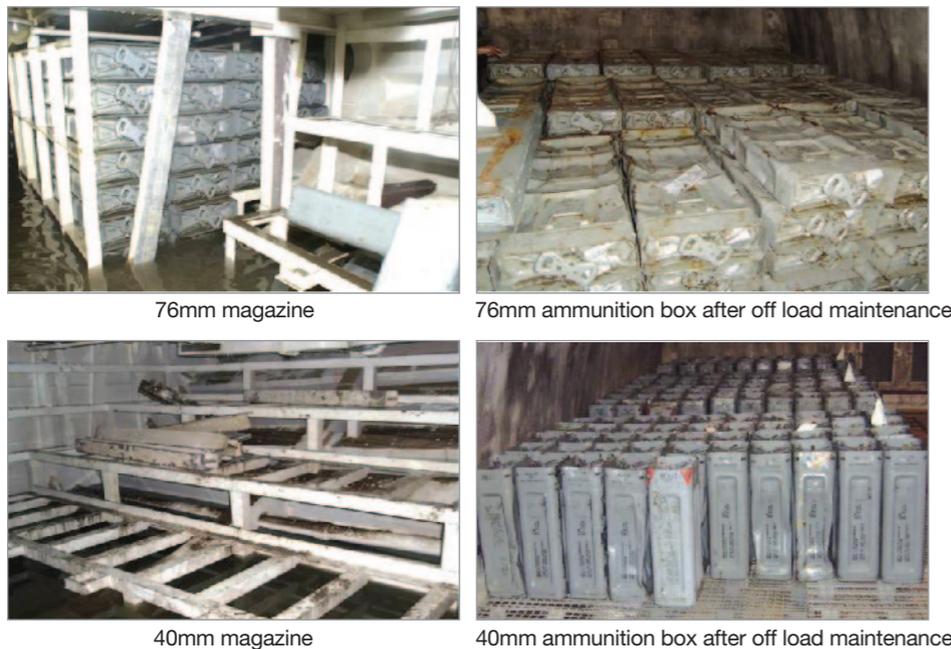
〈Figure II-2-3〉 Conditions of magazines after the hull recovery

In addition, the salvaged ammunition cases were only bent as a result of the water pressure without traces of an explosion(See 〈Figure II-2-3〉).

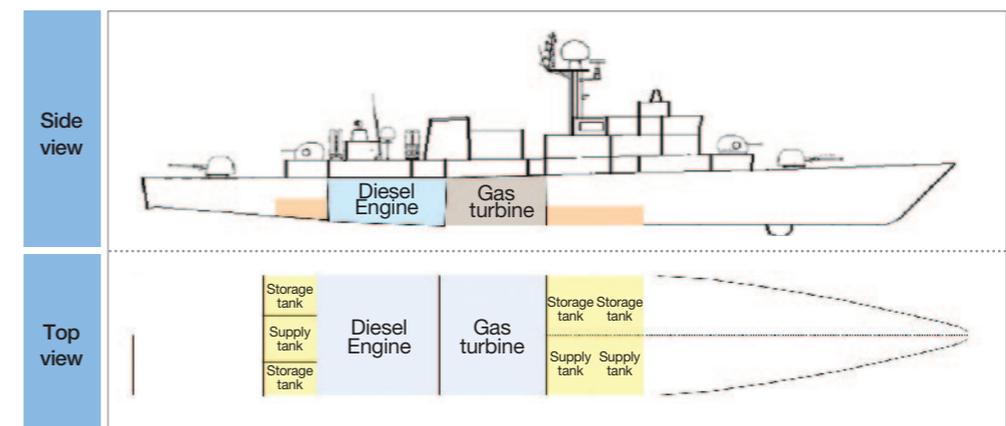
〈Figure II-2-5〉 Location of fuel tank of ROKS Cheonan

〈Figure II-2-5〉 illustrates the fuel tank locations of ROKS Cheonan. No damaged conditions were found after the inspection on these tanks, the remaining fuel was preserved, with no traces of fire or an explosion observed.

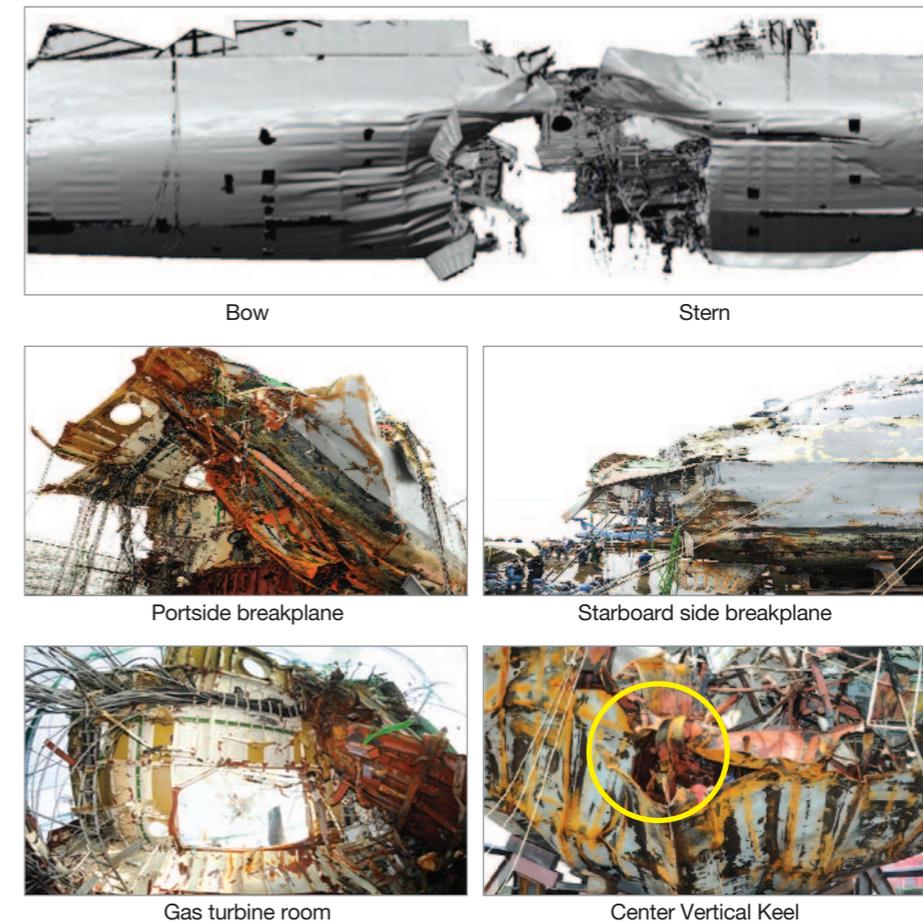
〈Figure III-1-2〉 Shape analysis

〈Figure III-1-2〉 indicates that the bow and stern's hull bottom are bent upward due to water pressure; the portside breakplane is bent and pushed upward; and 7.8m of the star-

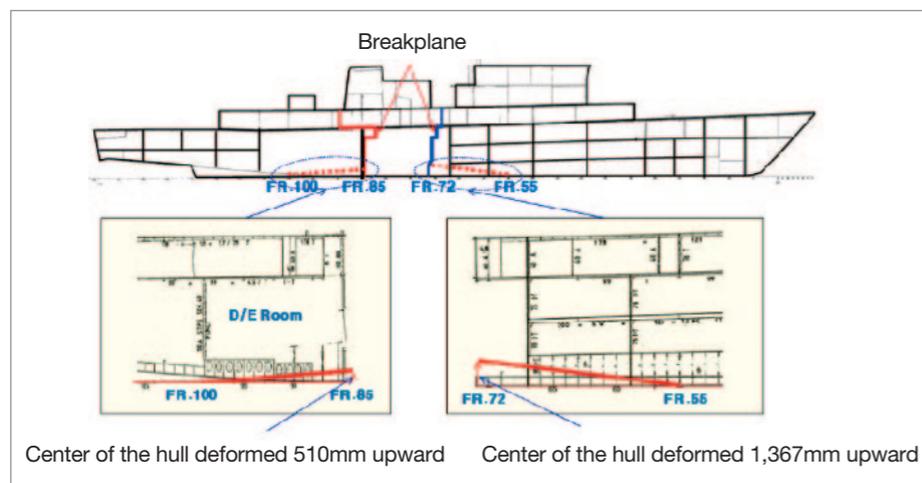
<Figure III-1-3> Starboard breakplane & CVK deformation

A precise deformation analysis was performed by 3 experts from the Defense Agency for Technology and Quality. The starboard side fracture was cut along Frame 72 and Frame 85 with a detachment of 7.8m as seen in <Figure III-1-3> and <Figure III-1-4>. The bow CVK deformation began in Frame 55 and moved upward towards Frame 72 for 1,367mm, and the stern CVK deformation began in Frame 100 and moved upwards towards Frame 85 for 510mm.

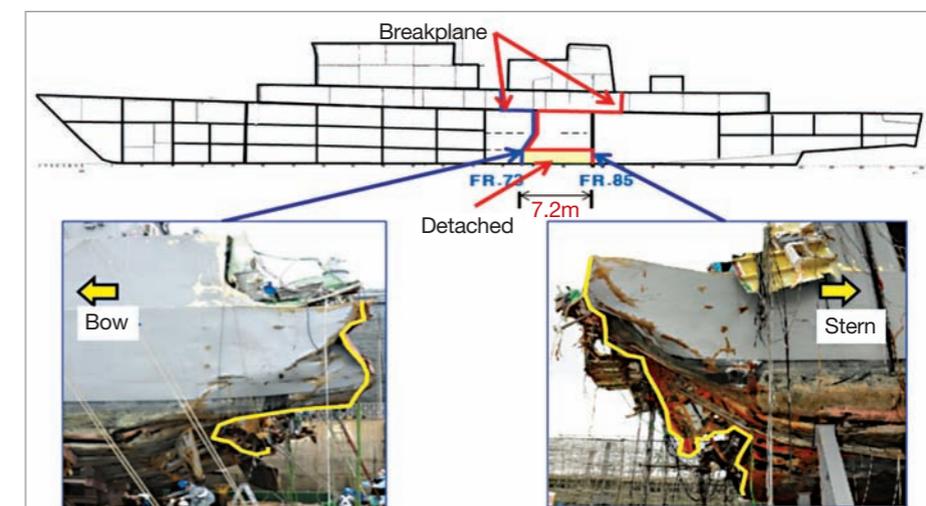
<Figure III-1-5> Portside fracture

As seen in <Figure III-1-5>, the portside was fractured from Frame 73 on, and the detached portion is about 7.2m long on the bottom. For the stern, the inside of the ship was bent upwards between Frame 85 and Frame 73(7.2m), and the bow was bent upwards from Frame 70 and 73(1.8m) on the inside of the hull. This enabled the JIG to rule out internal explosion, fatigue fracture, and grounding. It was assessed that the shock wave, generated by a strong non-contact underwater explosion initiating from the bottom portside, was delivered to the internal structures on the starboard side, and the hull was inflicted with serious damage as a result.

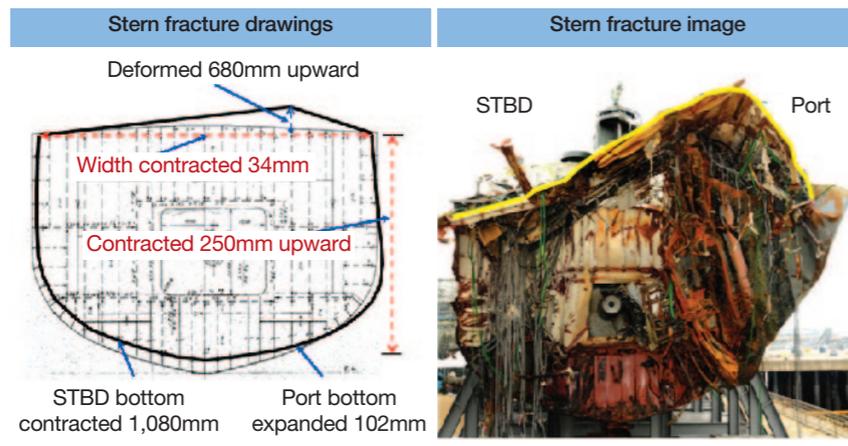
<Figure III-1-6> Stern breakplane deformation

The stern fractured surface on Frame 85, as shown in <Figure III-1-6>, shows that the center line of the ship contracted 250mm, that the portside bottom expanded 102mm along the width, and that the starboard bottom was compressed 1,080mm. The width of the Main Deck was compressed 34mm, and the hull was deformed 680mm upward from the point 3,600mm port from the center line.

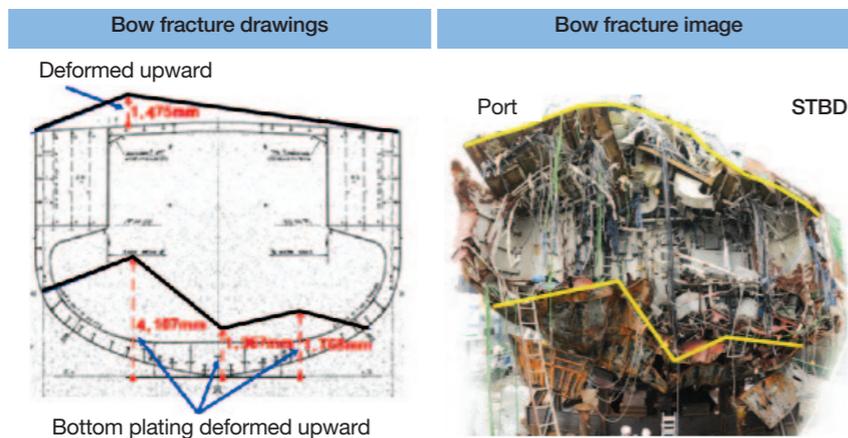
<Figure III-1-7> Bow fractured surface deformation

From the baseline, the bow fractured surface, as seen in <Figure III-1-7>, shows that the bottom was lifted upward at a maximum of 4,107mm at the point of 2,400mm to the portside. The CVK was deformed upward by 1,367mm, and the starboard bottom was bent upward by 1,758mm at the point of 1,800mm away from the baseline. The main deck was

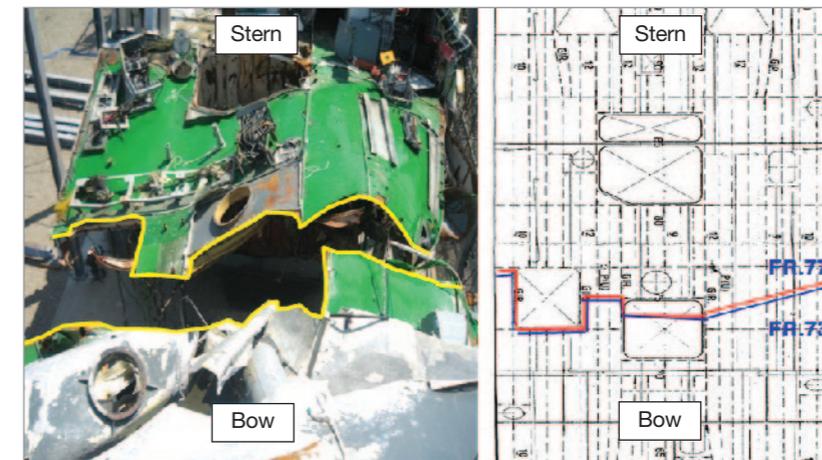
<Figure III-1-8> Main deck deformation

For the main deck, as seen in <Figure III-1-8>, the breakplane is located along Frames 73~77. The fracture occurred by the concentration of stress of an external force impacting on the round end of the deck opening, and the port side is more severely deformed upwards compared to the starboard side.

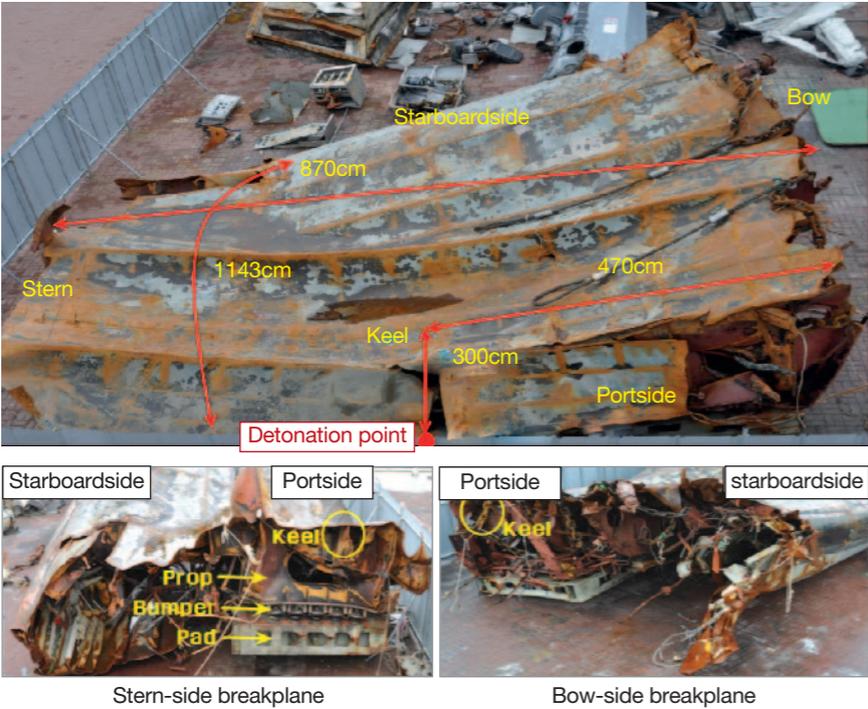
<Figure III-2-9> Salvaged bottom shell portion of gas turbine room

The salvaged gas turbine room was 8.7m in length and 11m in width on the hull bottom and on the starboard side, and weighed about 30tons as shown in <Figure III-2-9>.
