Response to “Rush to Judgment: Inconsistencies in South Korea’s Cheonan Report”

II. Comments by the ROK Civil-Military Joint Investigation Group in the ROK Ministry of National Defense

The ROKS Cheonan was split and sunk due to shockwave and bubble effect generated by a non-contact underwater explosion (depth 6~9m).

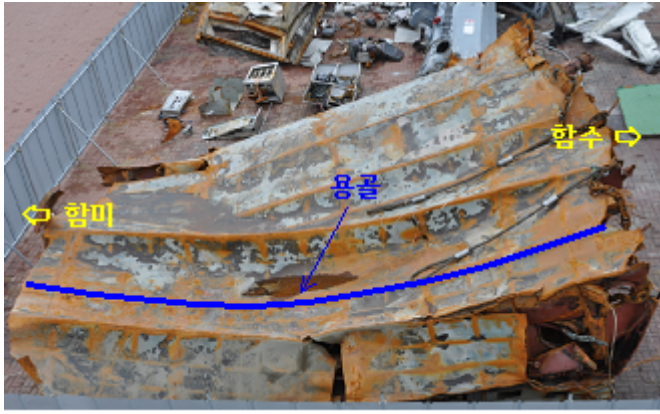
A non-contact underwater explosion occurred below the gas turbine room, splitting the hull from the forward and aft sections of the gas turbine room, and partially detaching the gas turbine room structures (Figure 1). The fractured surface is the forward and aft parts of the gas turbine room, and shearing fractures were observed along the area where the gas turbine room was ripped off due to the enormous external pressure exerted from the lower part, and brittle fractures were identified on the rest of the fractured surface. The gas turbine shell plates, under which a non-contact underwater explosion took place, were deformed in concave shape resembling the shape of the bubble (Figure 1). The stern bottom fractured surface, connected to the severed hull, also shows a spherical shape deformation (Figure 2).

Deformation Of Bow Hull Bottom

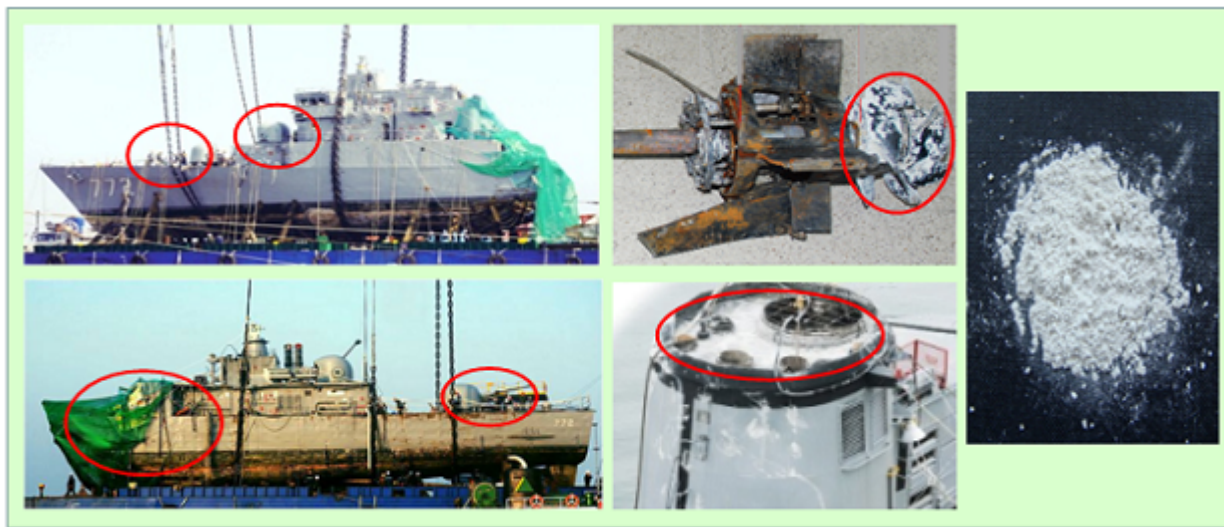
Analysis of Adhered Substances:

Collection of the adhered substances: Bow, stern, stack, and torpedo propulsion motor (10 locations)
