Response to “Rush to Judgment: Inconsistencies in South Korea’s Cheonan Report”

II. Comments by the ROK Civil-Military Joint Investigation Group in the ROK Ministry of National Defense

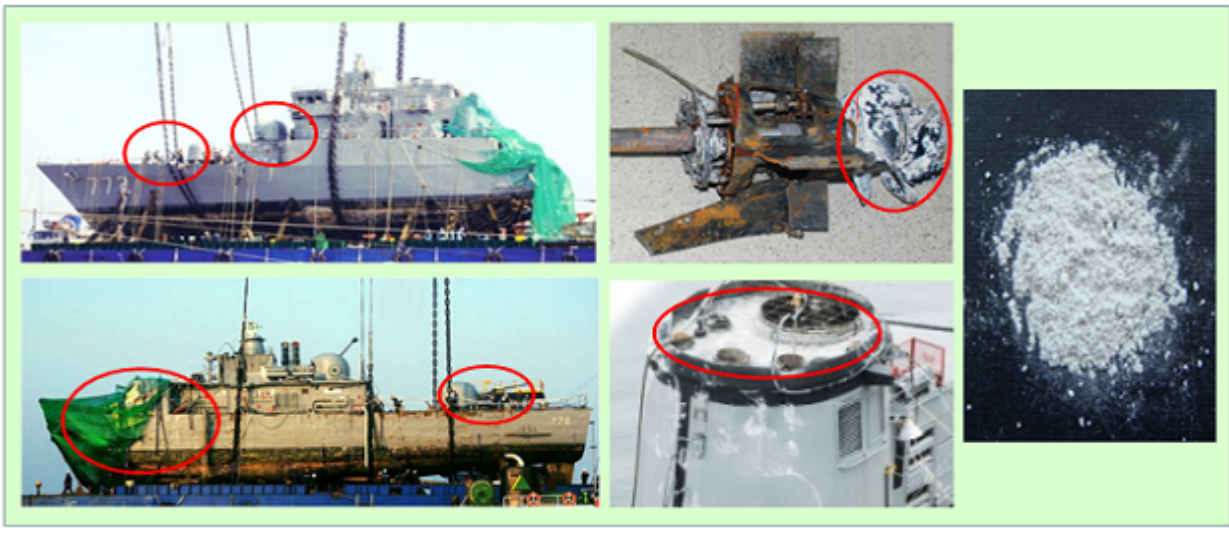
Analysis of Adhered Substances:

Collection of the adhered substances: Bow, stern, stack, and torpedo propulsion motor (10 locations)
